April 2023

Barrytown Mineral Sand Mine Ecological Effects Assessment

Submitted to:
TiGa Minerals and Metals Limited

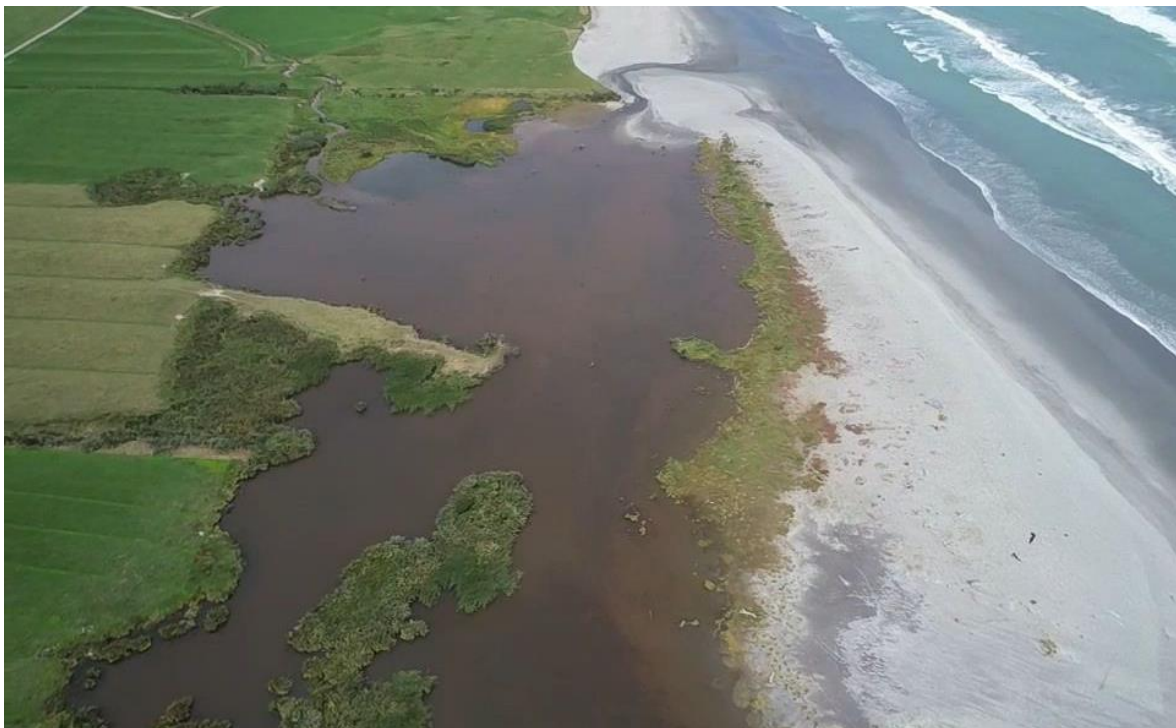
Water quality in the coastal lagoon has been measured on two occasions (23 August and 21 September 2022, J. Rekker pers. comm.). Results indicate that the turbidity is generally low (10.1 and 7.6 NTU respectively) and the pH circumneutral (7.1 and 7.4 respectively). Aluminium values are perhaps slightly elevated (0.055 g/m³ on one occasion, which is equivalent to the ANZG (2018) 95% species protection value), as are copper (0.0014 on one occasion, also equivalent to the ANZG (2018) 95% species protection value).

Figure 16: Coastal Lagoon at Nikau Deer Farm, Barrytown (Taken February 2023).

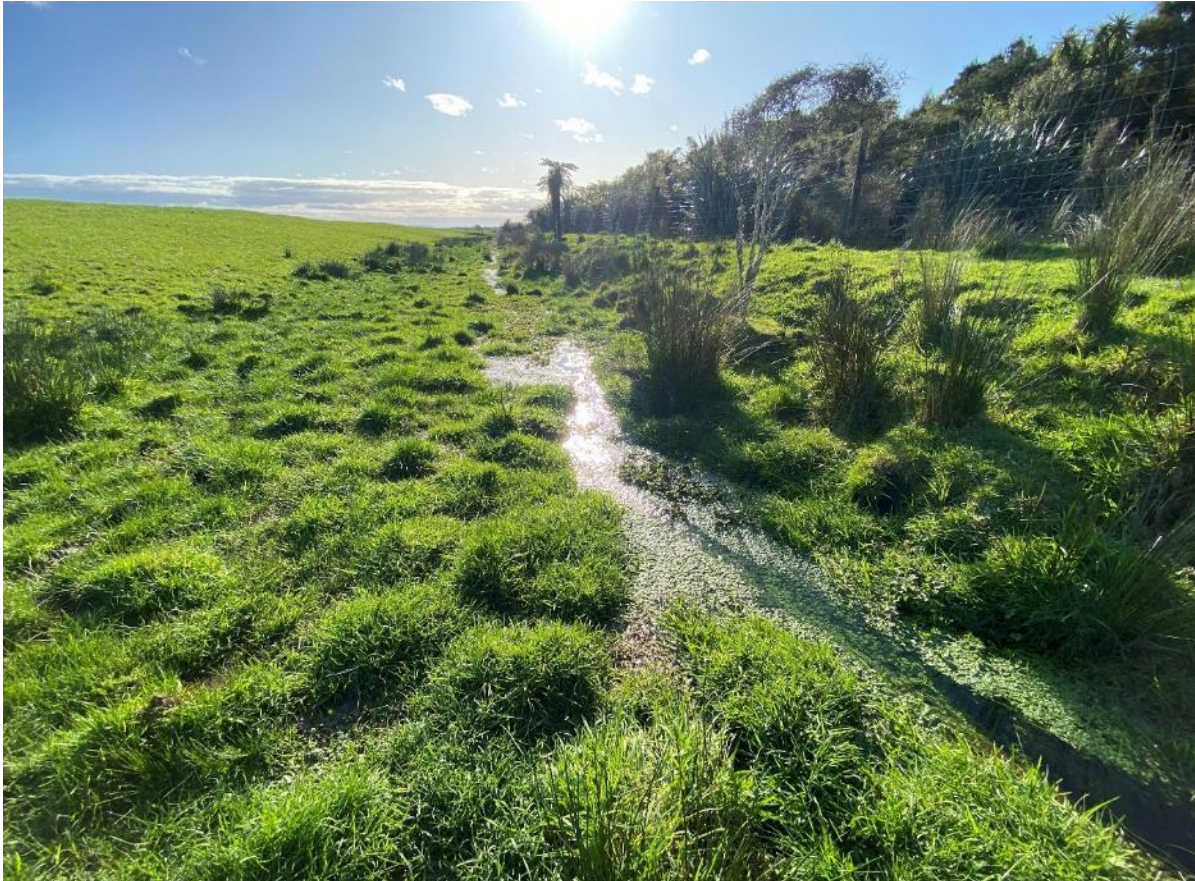
The Northern Drain is a highly modified soft-bottomed (sand/silt) watercourse with a straight channel alignment. The Northern Drain flows into a coastal lagoon located off-site near the north-western corner of the property. The Northern Drain had a wetted channel width ranging between 1.2 – 1.8 m and water depths between 0.14 – 0.34 m along the survey reach. Water velocities were sluggish and ranged between 0.05 – 0.2 m/s. Aquatic habitat was uniform and limited to runs and small pools.

The channel was poorly shaded due to a lack of tree/shrub riparian vegetation near the channel. The drain was unfenced on the true-left bank but fenced some 3 – 5 m away from the edge on the true-right bank, behind which was a stand of vegetation that included large kahikatea trees. Livestock had unrestricted access to both streambanks resulting in pugging of the streambank and direct channel disturbance. The poorly shaded channel was choked with macrophytes. The Northern Drain provides poor quality aquatic habitat.

Figure 18: Typical habitat conditions along the Northern Drain (Site 1).

Typical habitat conditions along the Northern Drain at the time of the survey are shown in Figure 18. The Northern Drain originates within the site as an ephemeral flow path in the north-eastern corner of the site that is also fed by an artificial drain running along the western side of State Highway 6. The Northern Drain is a modified natural watercourse that has been realigned into its current flow path along the northern boundary of the site. The Northern Drain was surveyed at Site 1 in the mid-upper reaches within the site which was representative of the general habitat conditions along the stream length.

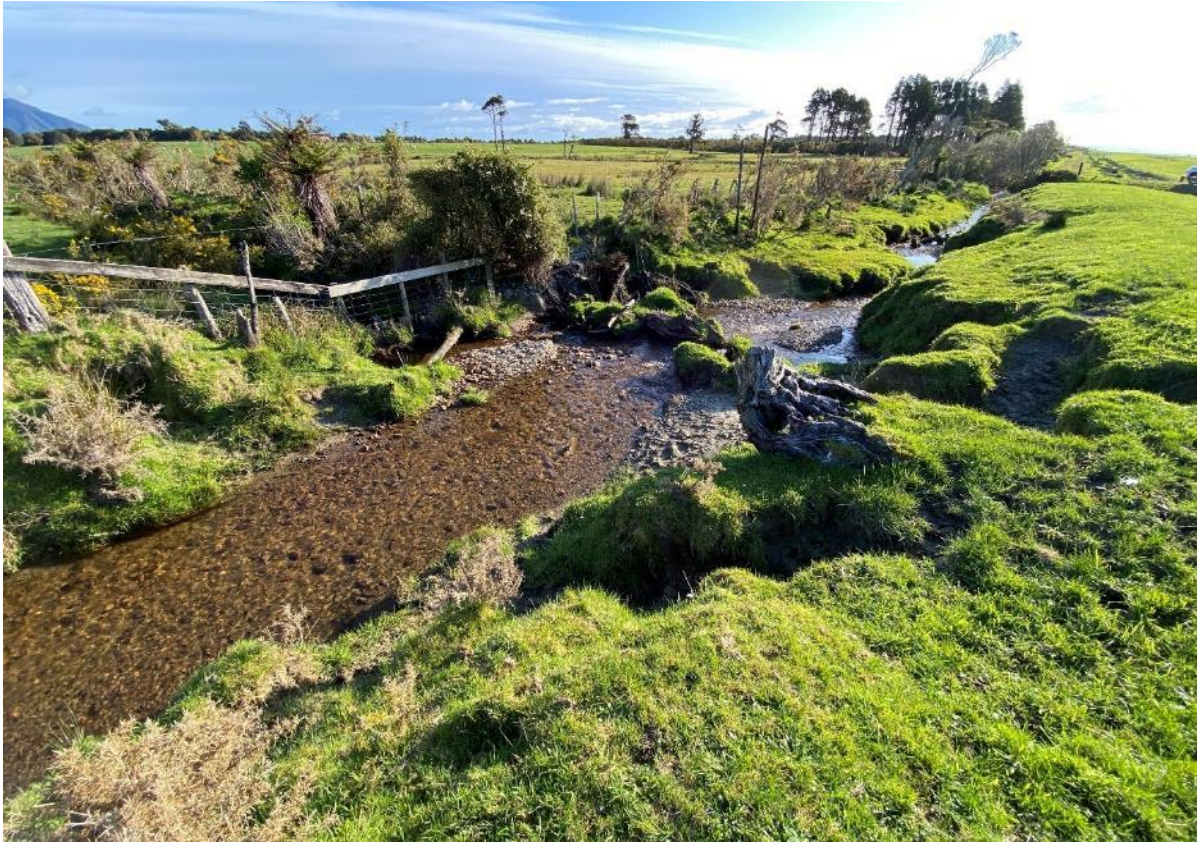
Collins Creek had wetted channel widths of 1.8–3.1 m, with water depths ranging between 0.08 m and 0.49 m. Aquatic habitat type and quality was variable and included riffles, runs and small pools with diverse water velocities ranging between 0.2–1.0 m/s. Riffle habitat was more abundant at the upper Collins Creek site, whilst runs were more common downstream. The streambed was generally stable and diverse and comprised cobble, gravel and sand, but a fine layer of silt was observed on instream surfaces, particularly at the lower site.

Streambanks were steep, unstable, pugged and eroding/slumping within the site. There was generally sparse riparian vegetation along Collins Creek limited to grazed pasture and occasional native/exotic shrubs (e.g., gorse (*Ulex europaeus*), tree ferns (*Alsophila*, *Sphaeropteris* and *Dicksonia* spp.), tī kōuka), however there was an approximate 350 m long section along the the middle section of the true-left bank of Collins Creek with native/exotic vegetation (shown in Figure 11). Collins Creek provides moderate-poor quality aquatic habitat and reflects its highly modified state and bank instability.

Figure 19: Typical habitat conditions along the upper Collins Creek (Site 2).

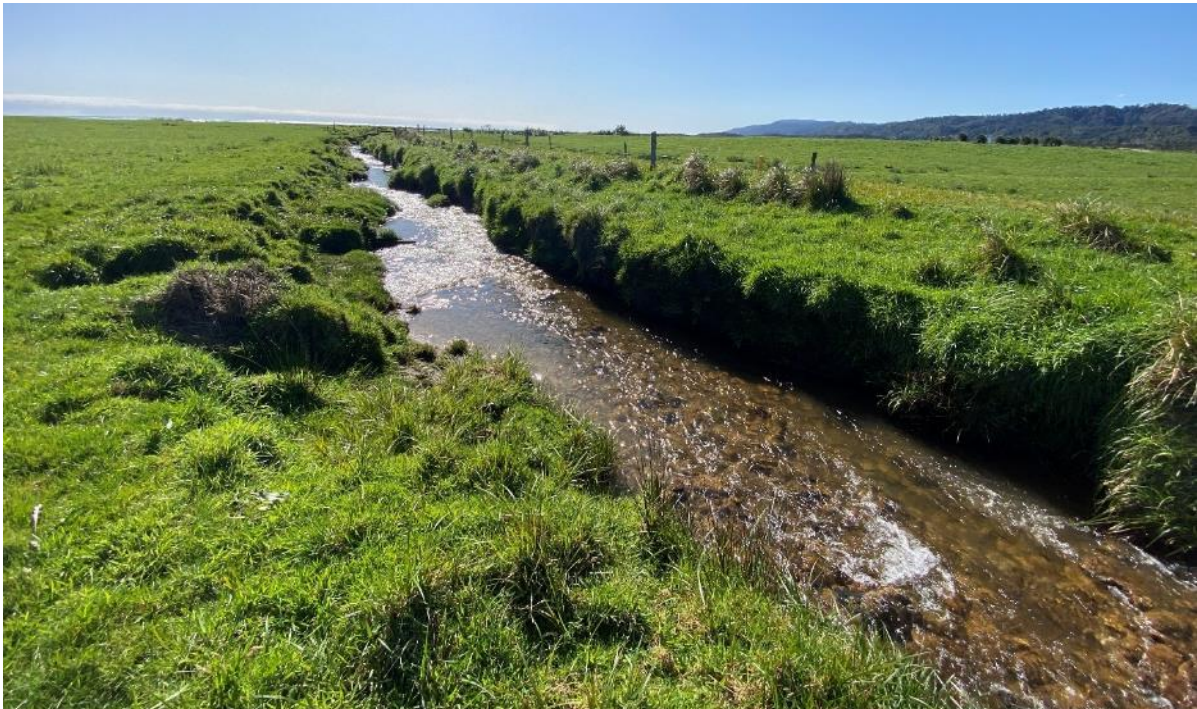
Figure 20: Typical habitat conditions along the lower Collins Creek (Site 3).

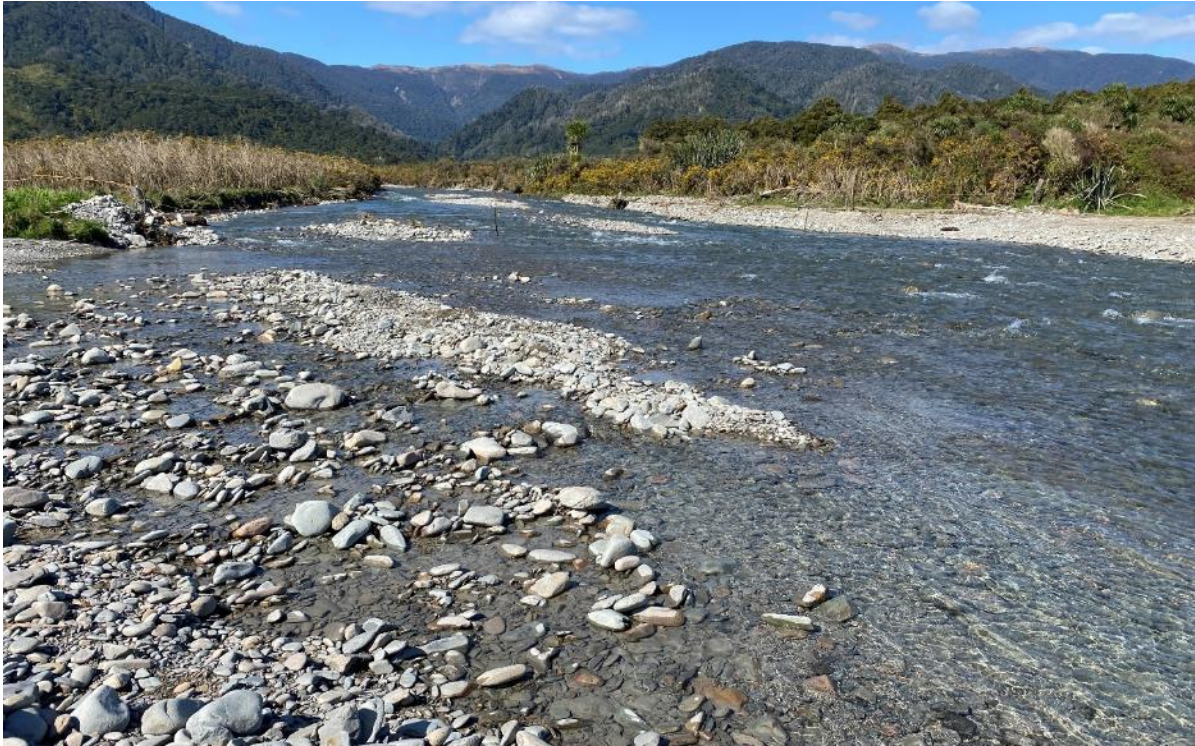
of Canoe Creek was surveyed at Site 4 as shown in Figure 21. Canoe Creek was in a natural state with wetted channel widths ranging 8 – 28 m and water depths of 0.13–0.38 m. The streambed was diverse and comprised boulder, cobble and gravel with a small proportion of sand. Aquatic habitat was diverse and included runs, riffles and pools. The wetted channel meandered within a wider cobble/gravel floodplain and was poorly shaded. Water velocities were swift in run and riffles and ranged between 0.4 – 1.6 m/s. Canoe Creek drains a steep catchment and is naturally a highly disturbed aquatic environment, but nonetheless provides high-quality habitat for invertebrates and native fish.

Figure 21: Typical habitat conditions along lower Canoe Creek (Site 4).

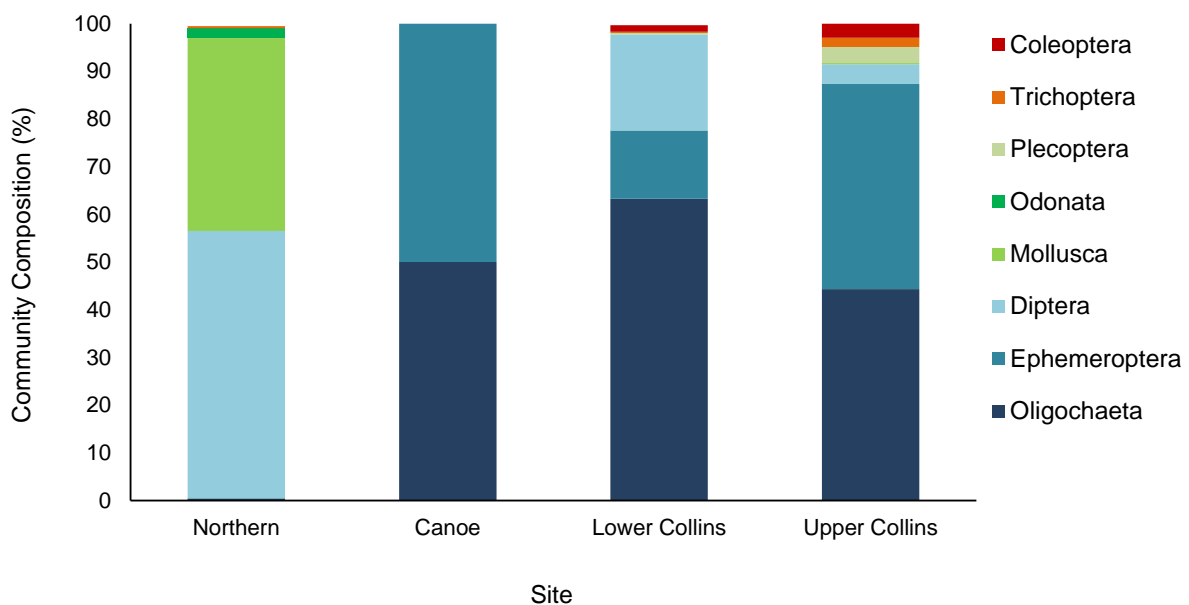
Relative abundance of the taxonomic groups making up invertebrate communities at sites is presented in Figure 22. Northern Drain was soft-bottomed and supported high proportions of tolerant species of Diptera (true-flies; 56%) and Mollusca (snails; 40%). Canoe Creek supported very low invertebrate abundance (mean = 2 individuals), so community composition results are not meaningful. The upper and lower Collins Creek sites supported high proportions of Oligochaeta (worms; 43–50%) and moderate-high proportions of Ephemeroptera (mayflies; 14–43%). Diptera were more abundant at the lower Collins Creek site (20%) compared with upstream (4%) and corresponded with a downstream increase in thick mat algae, filamentous algae and silt smothering instream surfaces. Coleoptera (beetle), Trichoptera (caddisfly) and Plecoptera (stonefly) also made up a small proportion of the community at the upper Collins Creek site.

Figure 22: Relative abundance of macroinvertebrate groups during the survey.

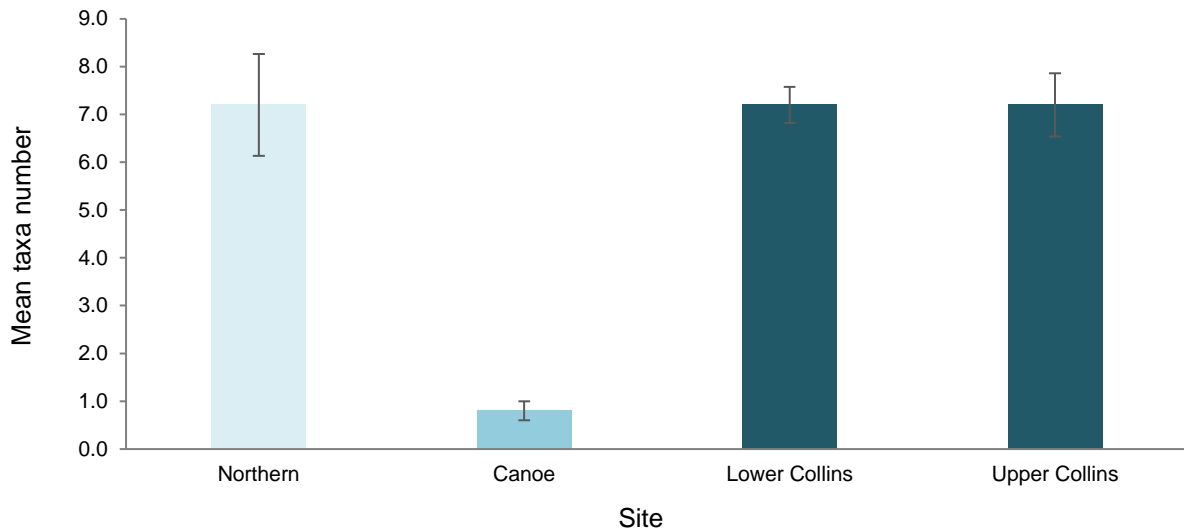
A total of 31 invertebrate taxa were collected across all sites. Mean taxa number was low to very-low at the four sites and ranged between 0.8 ± 0.2 taxa at Canoe Creek and 7.2 ± 0.4 – 1.1 taxa at Northern Drain and the upper and lower Collins Creek sites (Figure 23).

Figure 23: Mean (\pm S.E.) taxa number for sites during the survey.

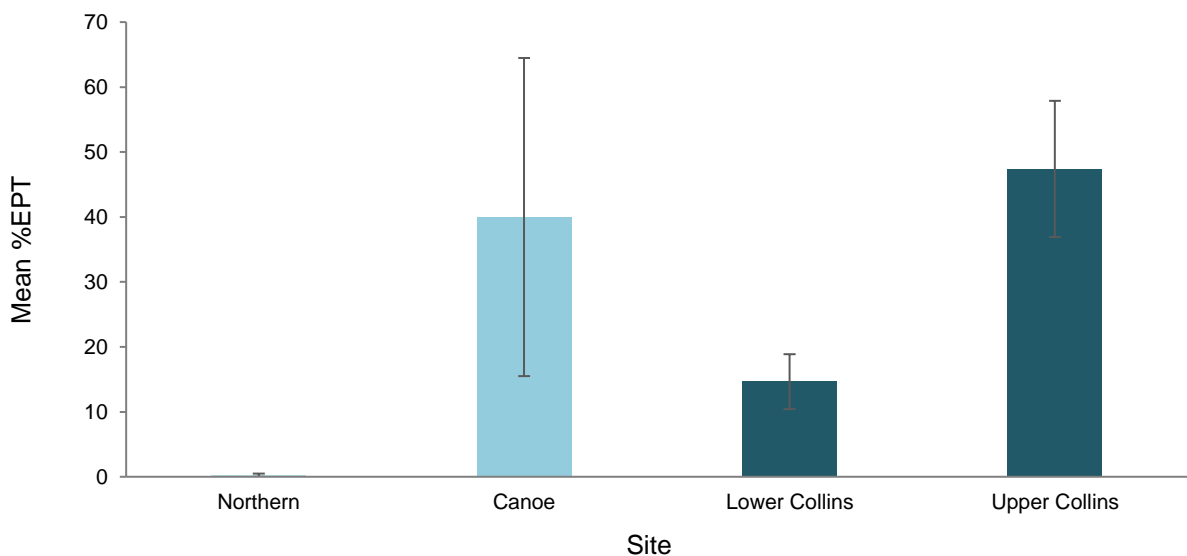
Canoe Creek means that the %EPT result is not meaningful. Upper Collins Creek had moderate-high %EPT ($47\% \pm 10$), which decreased to $15\% \pm 4$ in lower Collins Creek due to a downstream decrease in *Deleatidium* mayflies and increase in worm abundance between the two sites.

Figure 26: Mean (\pm S.E.) percent EPT abundance (%EPT) at sites during the survey.

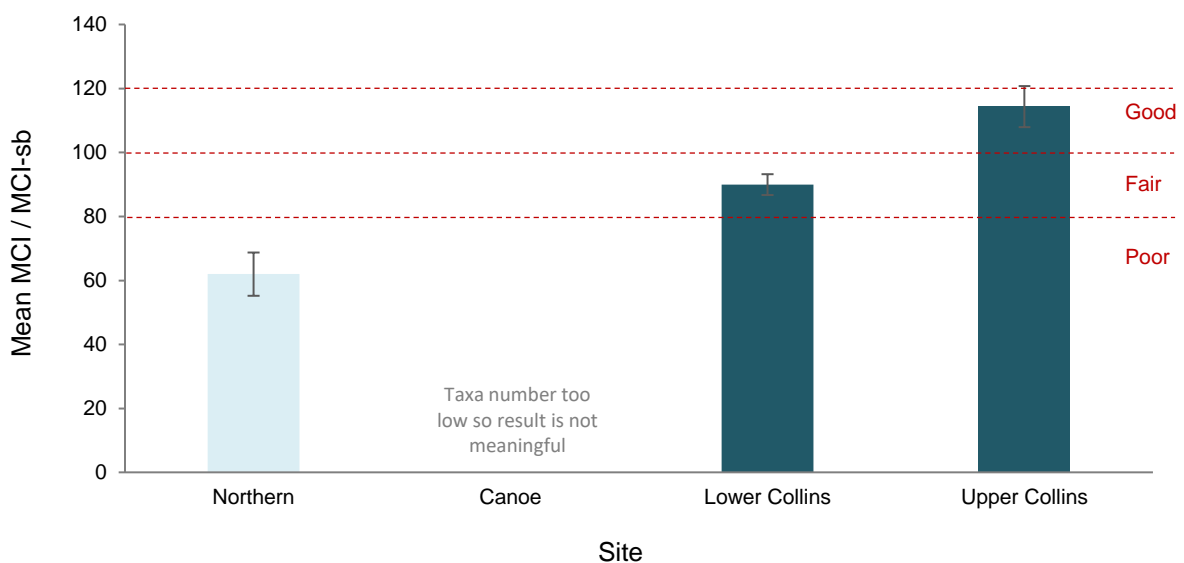
There was a decrease in MCI score between the upper and lower Collins Creek sites from 114 to 90 and a corresponding decrease in indicative stream health from 'good' to 'fair' (Stark and Maxted 2007). The higher MCI score for the upper Collins Creek site reflects the greater number of high-scoring EPT taxa, which were not recorded from the lower site. The MCI score for the upper Collins Creek site was within Attribute B of the NPS-FM and indicative of mild nutrient enrichment whilst the score for the lower Collins Creek site was just within Attribute C of the NPS-FM and indicative of moderate nutrient enrichment.

Figure 27: Mean (± S.E.) MCI / MCI-sb scores for sites during the survey.

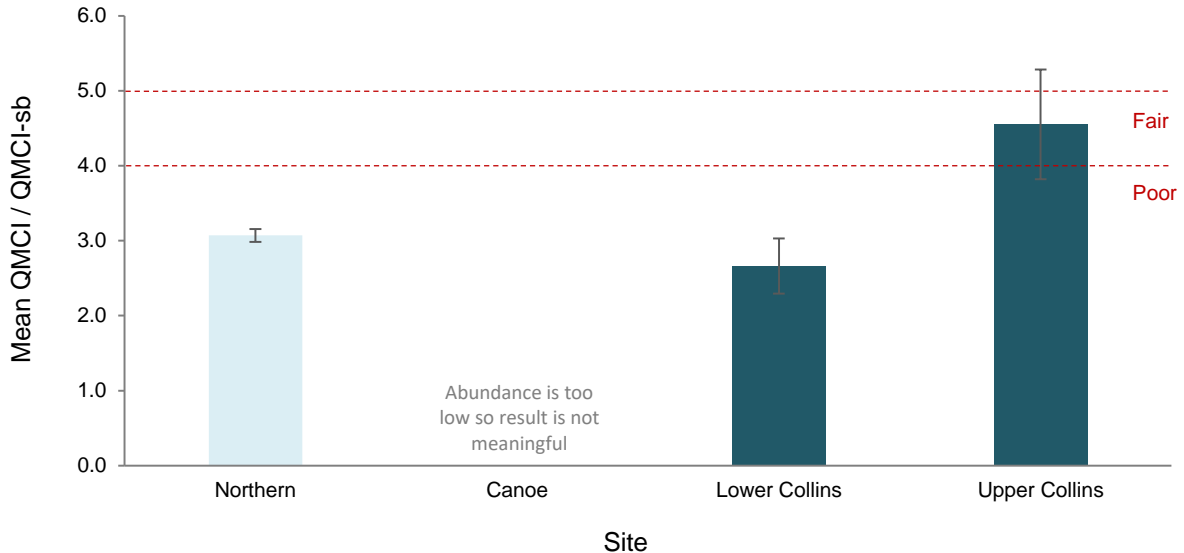
probable nutrient enrichment. The QMCI score for the upper site was indicative of ‘fair’ stream health (Stark and Maxted 2007) and within Attribute C of the NPS-FM that indicates moderate nutrient enrichment. The QMCI score for the lower Collins Creek site was indicative of ‘poor’ stream health (Stark and Maxted 2007) and below the National Bottom Line (Attribute D) in the NPS-FM indicating severe nutrient enrichment.

Figure 28: Mean (± S.E.) QMCI / QMCI-sb scores for sites during the survey.

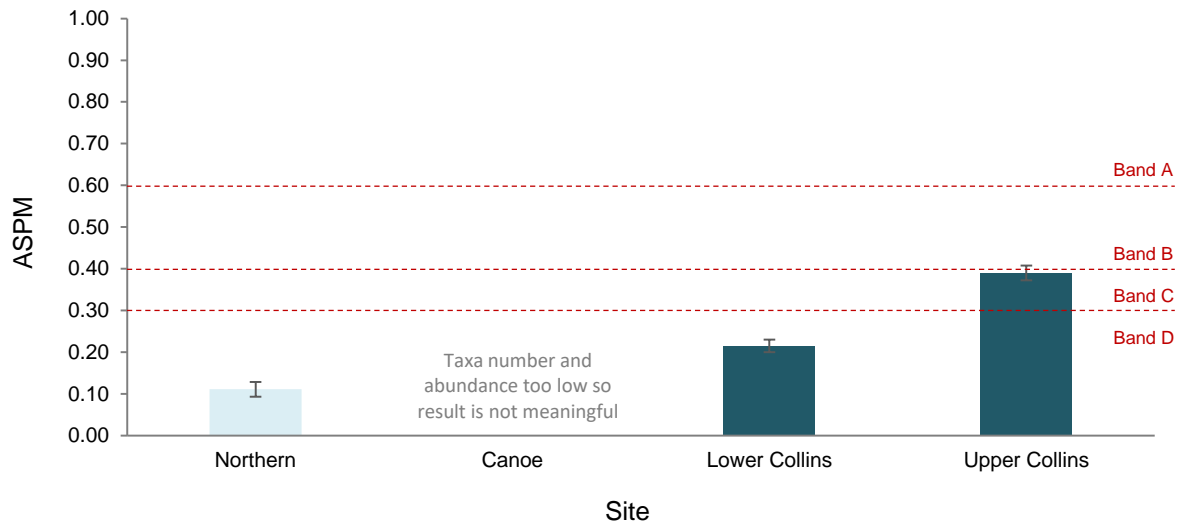
The mean ASPM score for the Northern Drain and lower Collins Creek were below the National Bottom Line (Attribute D) of the NPS-FM ($ASPM < 0.4$ and ≥ 0.3) and indicates the macroinvertebrate communities at these sites have severe loss of ecological integrity. The mean ASPM score for upper Collins Creek was in Attribute C of the NPS-FM and indicates the macroinvertebrate community at this site has moderate-severe loss of ecological integrity.

Figure 29: Mean (± S.E.) ASPM scores for sites during the survey.

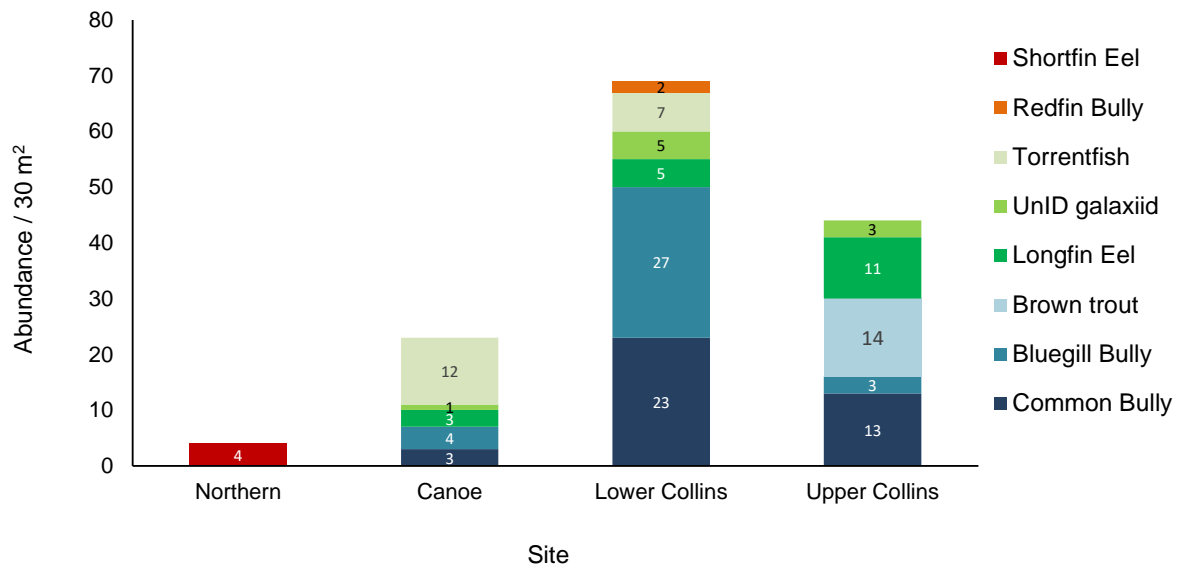
Eight fish species were recorded across the four streams during the 2022 survey. The abundance of each fish species recorded from streams during the survey is shown in Figure 31. Fish species recorded included longfin eel, shortfin eel, common bully, redfin bully, bluegill bully, bluegill bully, unidentified galaxiid (whitebait), torrentfish and juvenile brown trout (Figure 32). The most abundant species were common bully and bluegill bully.

Figure 31: Fish species and abundance recorded in streams during the 2022 survey, Nikau Deer Farm.
